Long-term measurement after 13 years

Fixit 222 Aerogel High-performance insulating plaster

EXPERIMENTAL SETUP FOR LONG-TERM MEASUREMENT

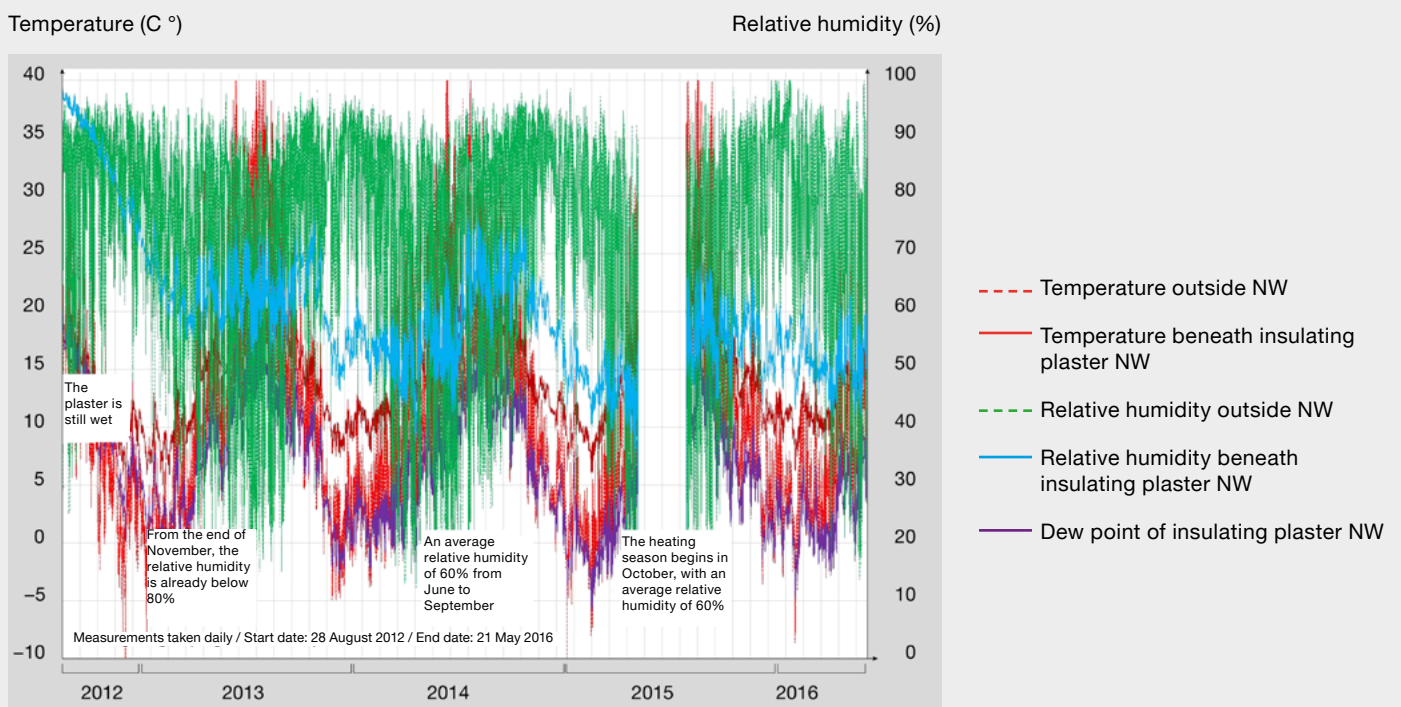
The temperatures of the outside air and beneath the insulating plaster on the masonry, as well as the corresponding relative humidity, were measured.

insulating plaster dried rapidly, so that the relative humidity beneath the insulating plaster was already below 80 % by the end of November 2012. By the second winter, the system had reached a steady state and the relative humidity was between 50 and 60%. The temperature difference between the outside air and the masonry averages between 6 and 8 °C during the winter months. The dew point temperature beneath the insulating plaster was never exceeded once the system had reached a steady state.

In simple terms: it remains warm and dry beneath the insulating render.

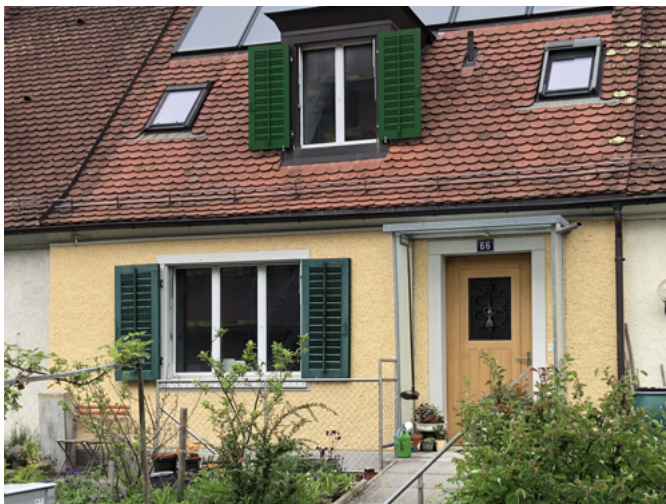
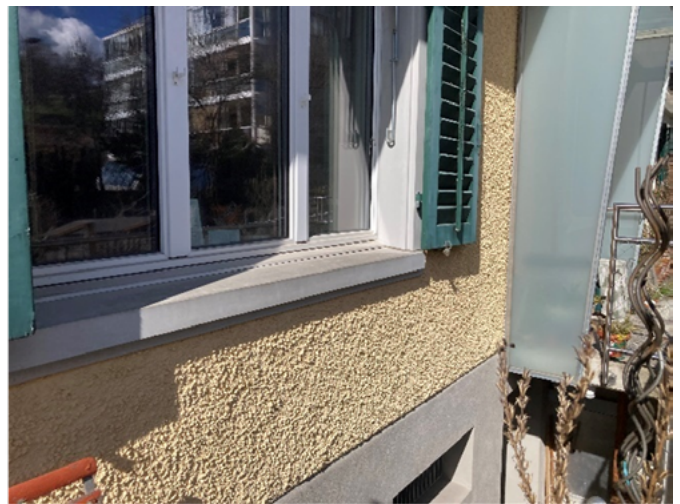
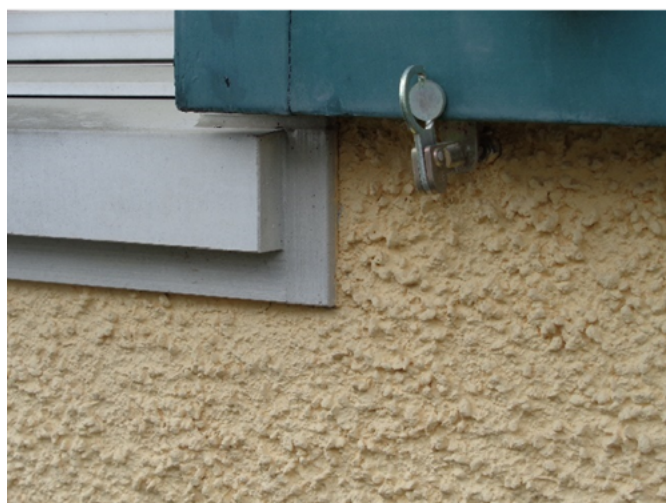
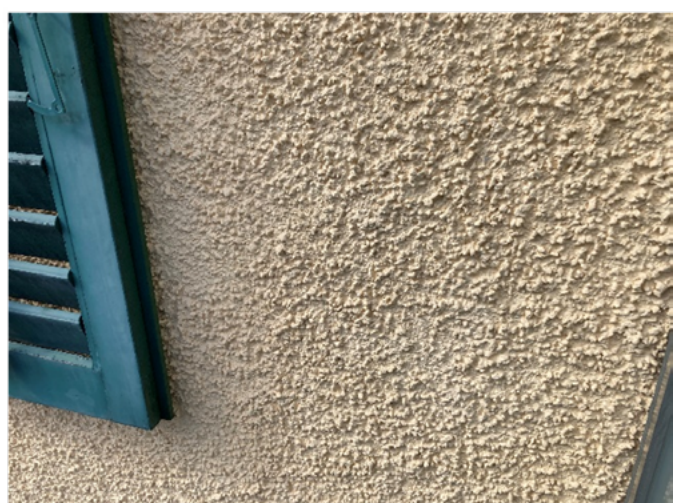
CONDITION AFTER 13 YEARS

NO VOIDS OR FLAKING

After 13 years, the façade was inspected once again. In March 2023, both façades were examined for any defects or damage. On the south-west side, the render was found to be in very good condition. The trowel finish and the mineral coating showed no signs of damage, such as hollow spots or flaking.

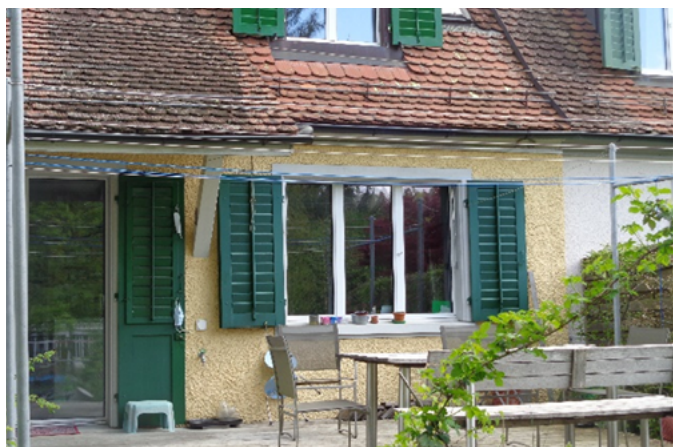
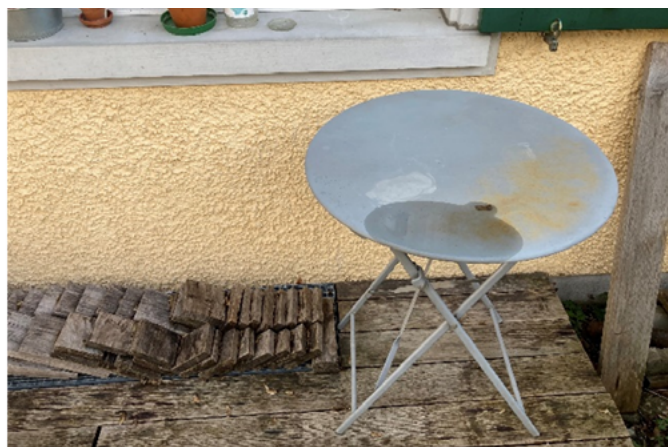
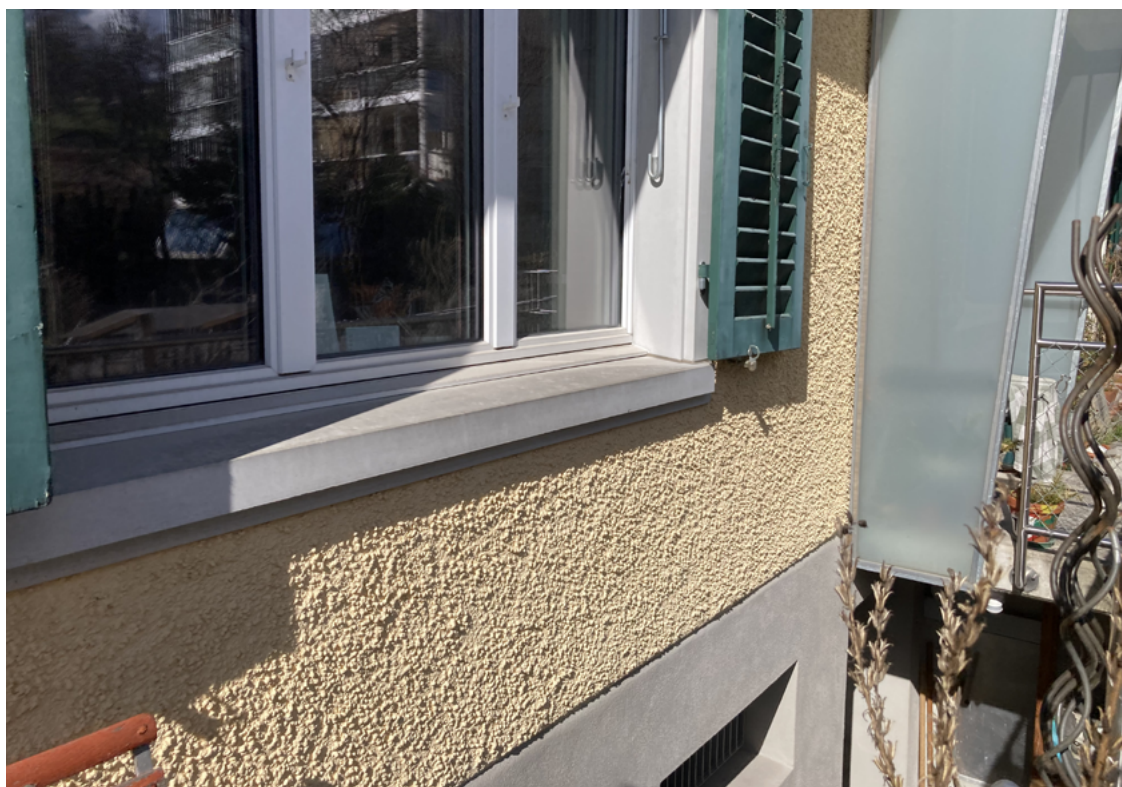
NORTH-WEST SIDE

The north-west side, too, was in very good condition after more than 10 years, with no damage. This was the side of the façade that was almost always completely in the shade and was exposed to precipitation (splash water). Even this heavily weathered area showed no visible damage.

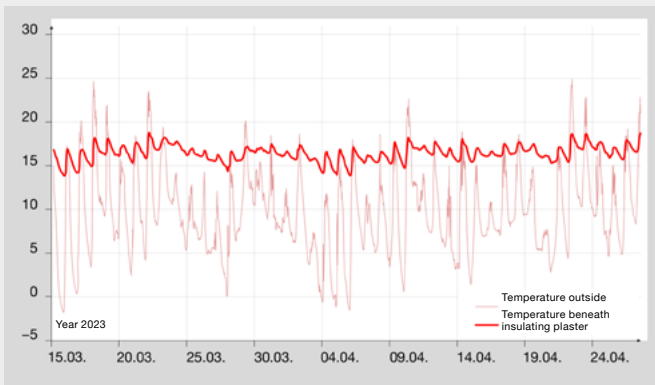
Temperature (C °)

From 25 March to 27 April 2023, the sensors installed in the south-east façade were reactivated. Beneath the Fixit 222 aerogel, the average temperature is 16 °C, which is approximately 8 to 10 °C warmer than the outside air temperature.

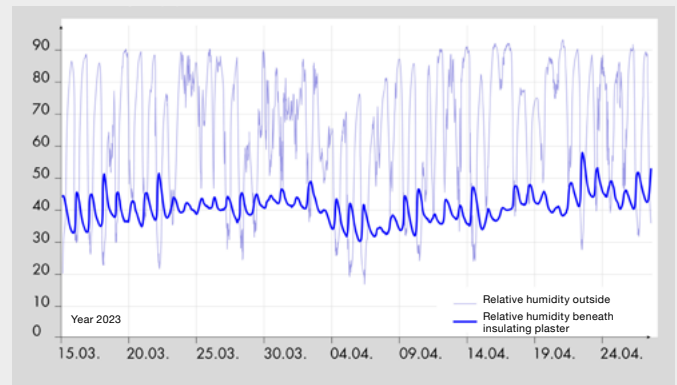
Relative humidity (%)

The relative humidity beneath the insulating plaster averaged 40%. This confirmed the measurements taken between 2012 and 2016.

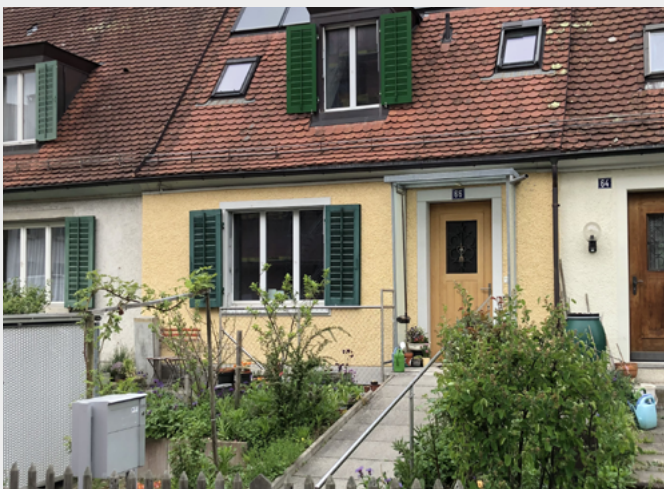
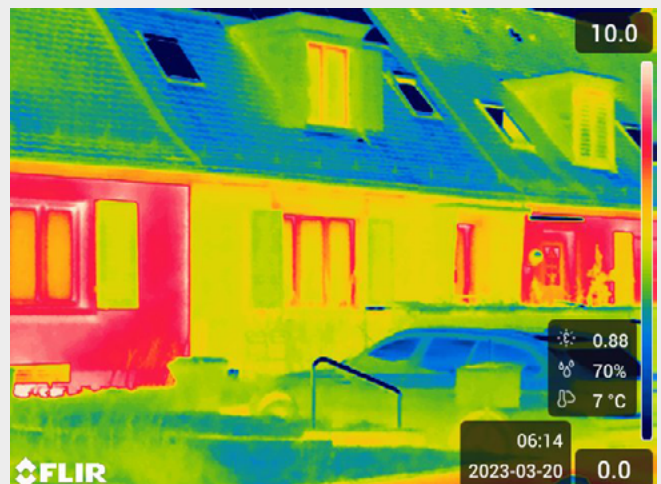
SOUTH-EAST FACADE

Thermographic images were also taken of the south-east façade. These clearly show the insulating properties of Fixit 222 Aerogel.

The two neighbouring houses to the left and right have significantly higher heat loss, which is evident from their higher surface temperatures. (red areas)
